## Staining and discolouration of galvanized steel by rust

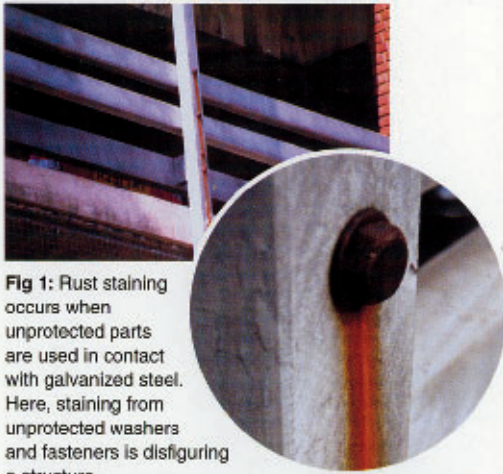
**Fig 1:** Rust staining occurs when unprotected parts are used in contact with galvanized steel. Here, staining from unprotected washers and fasteners is disfiguring a structure.

- 1: Direct contact of galvanized parts with unprotected or inadequately protected steel (e.g. galvanized steel sections fastened with unprotected, electroplated or painted steel bolts).

All parts of the structure should receive comparable corrosion protection where possible. Nuts and bolts and other fasteners should be hot dip galvanized to BS 7371: Part 6: 1998. The thinner zinc coatings frequently supplied on steel mesh, sheet, wire and tube will not last as long as those of products hot dip galvanized to BS/IS EN ISO 1461, the standard which covers all structures galvanized after fabrication.

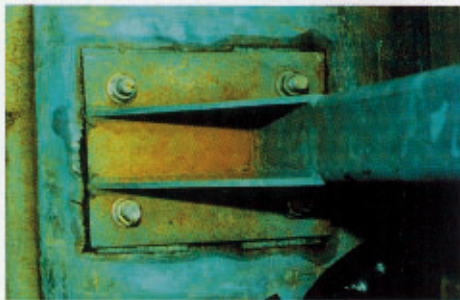
**Fig 2a:** When steel is cut or drilled after galvanizing, the swarf must be removed. If it is left on the component rust staining may occur.

- 2: Deposits of iron dust and swarf from other operations or sources onto the galvanized surface.
- 3: Water draining from unprotected or poorly protected steelwork, e.g. from damaged areas on painted steelwork.

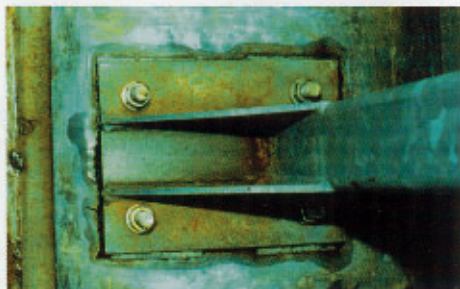
**Fig 2b:** This staining is superficial and can be removed to expose a sound galvanized coating beneath.

Discolouration and staining have no effect on the life of the coating. However, affected areas may be cleaned to improve the appearance of the structure. Generally, wire brushing or the use of a scouring powder will remove the stain and leave a sound galvanized coating.

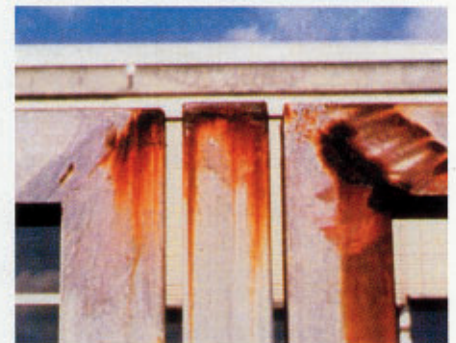
**Fig 3:** Where galvanized structures are welded, the steel exposed must be adequately protected (see text). Where this is not done, severe rust staining occurs as shown in this illustration.

- 5: Rusting of areas welded after galvanizing and subsequently left unprotected or inadequately protected.
- 6: Staining of galvanizing can occur when water runs off other materials notably metals such as copper, certain hardwoods, e.g. oak, and indeed whenever water can dissolve materials from one surface and redeposit on the galvanized steel.

Where welding after galvanizing is necessary, welded areas should be thoroughly cleaned and the zinc coating restored either with an appropriate thickness of zinc rich paint or with a proprietary repair compound, in accordance with section 6.3 of BS/IS EN ISO 1461.

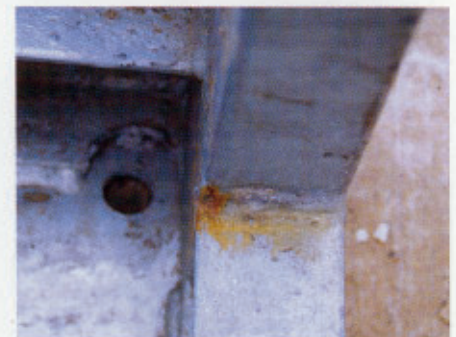
**Fig 4:** Seepage from pretreatment solutions from a weld

- 4: Seepage from pickle residues in welds. During pickling, hydrochloric acid may penetrate into the weld area via pin holes or if the welding is intermittent. Residual salts can sometimes pick up water and cause 'weeping' from the weld areas. This effect is normally limited to a small area, ceases after a short time and is not detrimental to the coating.

Welds should be continuous and slag-free wherever possible to minimise the retention of pickle residues.

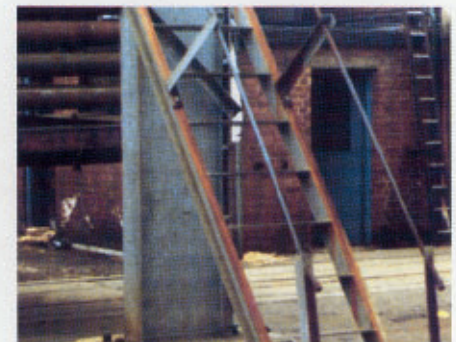
**Fig 5:** Water draining from rusting steel (out of picture) causes staining of sound galvanized surfaces of the stairway illustrated here.

Design structures to avoid run-off water from other metals on to galvanized steel. In particular avoid run-off from inadequately protected steel and from copper.
